## SAFETY ALERT 01/25

# Buoyancy Compartment Hatch Covers

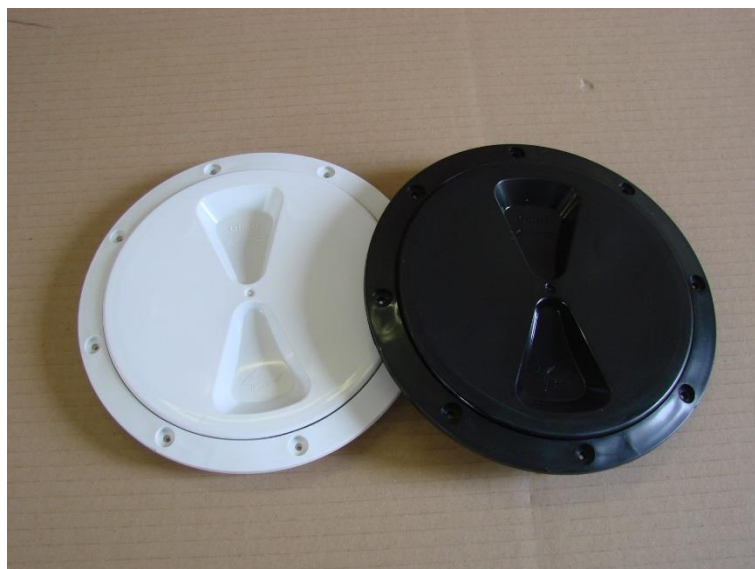
At a regatta during a pre-boating check by an umpire a single scull was found to be missing the hatch cover for one of its buoyancy compartments. The hatch cover had been replaced by strips of electrical insulating tape.

The buoyancy compartments on any boat are intended to be air and water tight. Not only should the hatch cover prevent water entering directly but it should also prevent air escaping. Should the boat suffer damage whilst afloat that allows water to leak in to the compartment then the trapped volume of air will limit the amount of water ingress by becoming pressurised until the pressure within the compartment is equal to the external water pressure.

For this to work the hatch covers should be airtight and they are normally fitted with a sealing arrangement (typically an 'O' ring or flat rubber seal). If the seal is missing or the cover is replaced by tape then in the event of water ingress the air volume will not become pressurised (any tape will be lifted off the hatch by the internal pressure within the compartment), the boat will lose buoyancy and either sink or not be able to support the weight of the crew.

The boat was not permitted to be used until a proper hatch cover had been fitted.
